# AUTOMOTIVE COATING

## ***Application Defects***

*By Clifford K. Schoff, Schoff Associates*

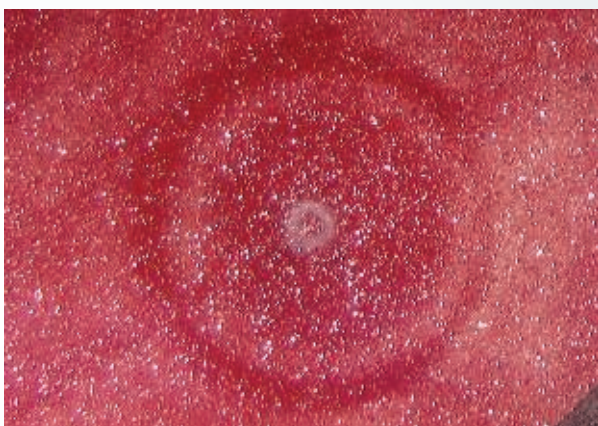
**FIGURE 1—Basecoat crater due to contaminant in the primer.**

Nearly all coatings people are familiar with craters, but they may not know much about them. Craters are caused by low surface tension contamination that is on the substrate being painted, is in the paint, or falls on the paint. This produces a surface tension gradient that causes flow away from the low surface tension area, resulting in a circular low spot (see *Figure 1* for an example). Shallow craters often can be polished out, but deep ones require sanding and repainting. Craters vary in size and appearance, even from a given contaminant. The majority of cases that I have encountered in auto plants have involved contaminants falling on the wet coating during or soon after application, but

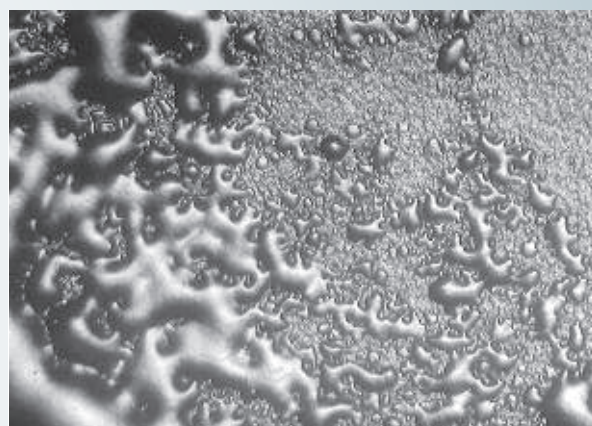
**FIGURE 2—Example of severe dewetting.**

Other surface tension-related defects include dewetting, telegraphing, and picture framing. Let's begin with dewetting. Although spraying usually is effective at force wetting of the surface of a substrate or undercoat and spreading a film across it, during or shortly after application there may be a pulling back or retracting of the film. This behavior is called dewetting or crawling. The paint appears to initially wet the surface, but cannot sustain this contact and pulls away. Dewetting also can produce beads of paint, islands, craters, or pinholes (see *Figure 2*).

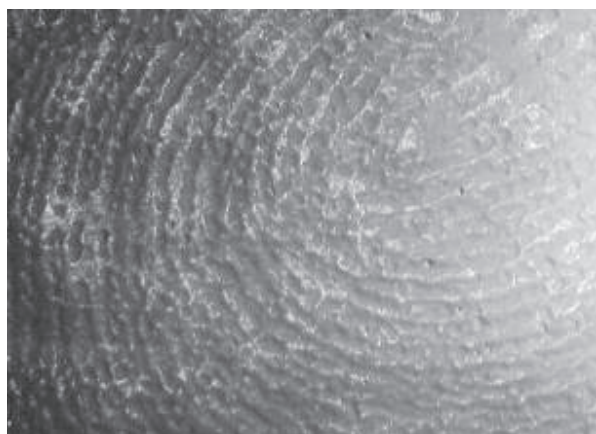
**FIGURE 3—Magnification of telegraphing of a fingerprint. The surface should be smooth.**

Telegraphing is a defect that involves the reproduction of surface features on an undercoat or substrate by the coating applied over it (*Figure 3*). Most examples that I have seen were where a basecoat made fingerprints,

The main cause of this defect is flow due to surface tension: flow away from residues such as finger oils and sanding dirt or flow away from sharp edges of sand scratches. Aluminum flakes in automotive metallic coatings have been known to line up along sand scratches or wipe marks, leaving silvery streaks noticeable from a considerable distance.

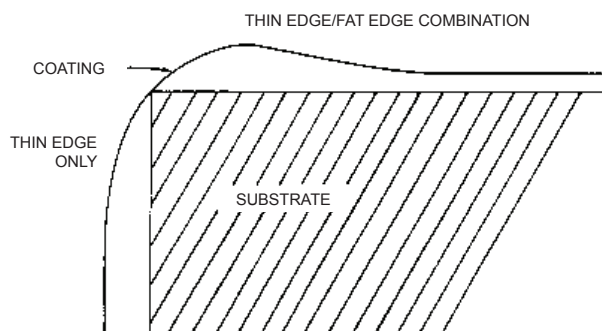
**FIGURE 4—Diagram showing a thin edge (poor coverage) and a fat edge.**

Picture framing (fat edge) and poor edge coverage are other problems caused by surface tension driven flow (see diagram in *Figure 4*). Picture framing is most common along door jambs, under windows, and along other edges of an auto or truck body. In some cases, it may be from electrostatic wrap or other spraying effects, but it usually is caused by surface tension gradients during baking.

A different, but related, defect is flow away from sharp edges during the bake so that a cut edge or sharp style line will end up with little or no coverage on it (also shown in *Figure 4*). This is because surface tension forces work to minimize the surface area of the coating. This used to be a serious problem with ED primers, which produced good edge coverage on deposition, but flow on baking resulted in very thin or no coverage on sharp edges. This was noticeable as “blue edge” and sometimes gave corrosion problems. Adding more pigment prevented flow away from the edge, but gave rough, ugly coatings.

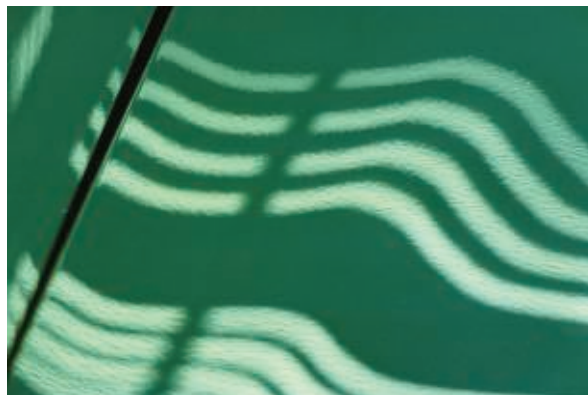
**FIGURE 5—Orange peel as seen in the reflection of overhead lamps on a car hood.**

Orange peel normally is due to poor flow-out and leveling of spray droplets, but occasionally is caused by surface tension driven flow (sometimes called sinks and bumps) in the oven. I also have seen a few cases where a rough basecoat produced an orange peel appearance even though the clearcoat surface was smooth (optical illusion?). Orange peel rarely affects gloss, but the bumpy surface can hurt distinctness of image (DOI), another sought-after appearance parameter. This can be seen in *Figure 5* where an auto hood with orange peel gives fuzzy, indistinct reflections of the overhead lights.

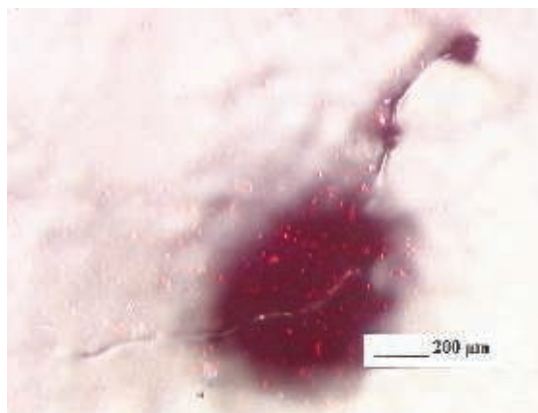
FIGURE 6—A typical piece of dirt in an automotive coating, a fiber.

Dirt that shows up on or in paint films may include fibers, sanding dust, metal particles (including weld balls from the body shop), oven dirt (condensate and carbonized resin), and general dust and grit. *Figure 6* shows a fiber, probably the most common type of coatings dirt. However, relatively few pieces of dirt are so easy to see. Most dirt defects are just bumps and must be cross sectioned to get an idea of what is in the bump. *Figure 7* shows an example. Resin gel particles, pigment agglomerates, and paint chips and flakes also may be considered as dirt. There are other defects that resemble dirt such as paint drops, gun spits, and overspray. These and substrate defects, solvent pops, and gassing have been mistaken for dirt many times and have led to much effort spent working on the wrong problem.

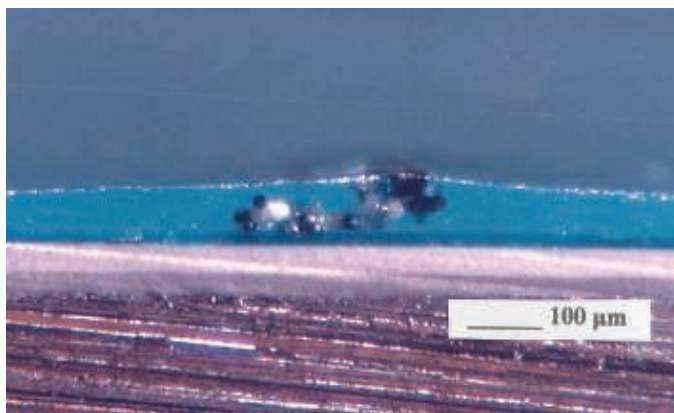
FIGURE 7—Cross section of overspray particles in a clearcoat.

temperature) leaves water in the basecoat, which then is expelled through the clear producing defects. Sloppy paint application also can lead to popping. Overspray and spits can trap solvent, blow out on baking, or absorb solvent from subsequent coats, then blow out from underneath the second coat. Irregular spraying can give thick spots that pop as do electrostatic spray wrap, fat edges, or sags.

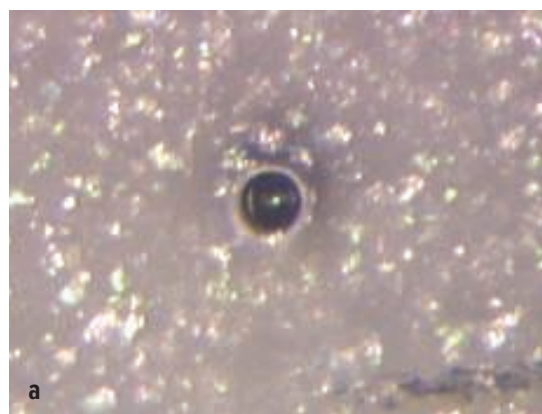
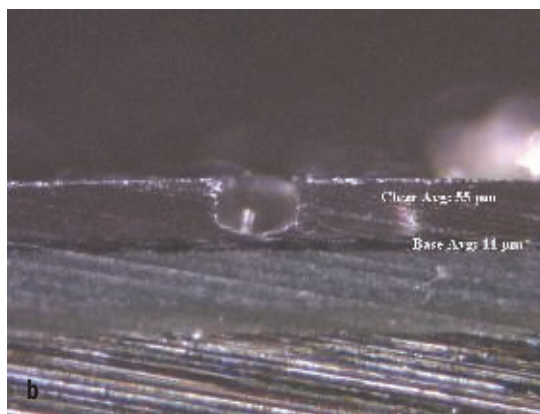
FIGURE 8—A solvent pop in an automotive base/clear (a) and its cross section (b).

Popping involves the formation of defects by the blowing out of trapped solvent or other volatiles during baking. The result may be miniature volcanoes, pinholes, craters, dimples, bubbles, or a few of each. The defect is often called solvent popping, but may be due to

volatiles from the substrate (also called gassing) or air entrapment. It can be very difficult to distinguish between these mechanisms, although true solvent popping is more likely to involve several or all of the defects listed above. It may be necessary to cross section pop suspects to make certain that they really are pops and to identify the source layer (*Figure 8*). With the introduction of waterborne basecoats, a new source of popping became apparent. Dehydration of these basecoats can lead to pops in clearcoats applied over them. Too much dehydration (high bake temperature) can produce a porous basecoat, which takes in solvent from the clear, which later blows out resulting in pinholes or pops. Too little dehydration (low bake

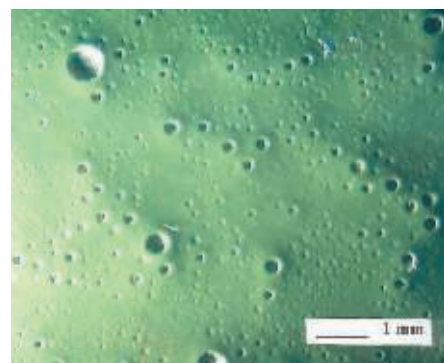
**FIGURE 10**—Pinhole gassing in an acrylic electrodeposition coating.

Another defect, similar in appearance, called pinhole gassing or rupture, can occur in electrodeposition primers at high deposition voltages. With cationic electrodeposition, the defects are caused by a mechanism that involves electrical discharge followed by hydrogen evolution and water vaporization. *Figure 10* shows pinhole gassing in an acrylic cationic electrodeposition coating used on agricultural equipment. Electrical discharge is more likely to occur over zinc coated steels, especially zinc-iron alloys, but it can occur over cold-rolled steel. The defects can be prevented or reduced by lowering and/or ramping or stepping voltage, adding solvent and raising the bath temperature.
