Morphological Changes in Exterior Exposure to Cyclic and Ultraviolet

Surface Coatings After Water Submersion Exposure

By Armin B. Burghart, Sridhar G. Iyer, and William J. Rosano
BASF Corporation

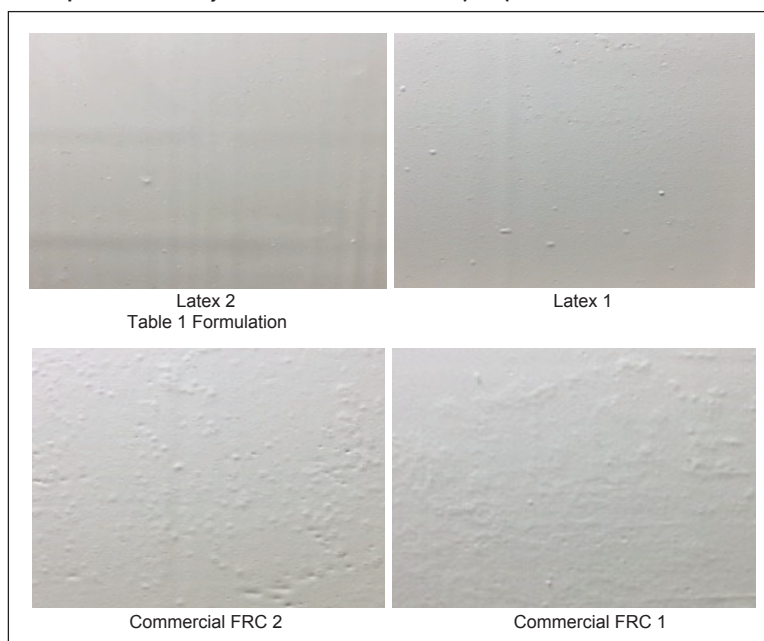
Figure 1—Visual images of FRCs after two weathering cycles. One cycle is one week of UV-A exposure followed by a one-week water immersion (60°C).

Figure 1 shows photographs of the four acrylic FRCs applied to galvanized steel after two weathering cycles where each cycle was one week of exposure to UV-A radiation followed by one week of immersion in 60 °C DI water. In general, the common visual defects, if they occurred, were small blisters and surface

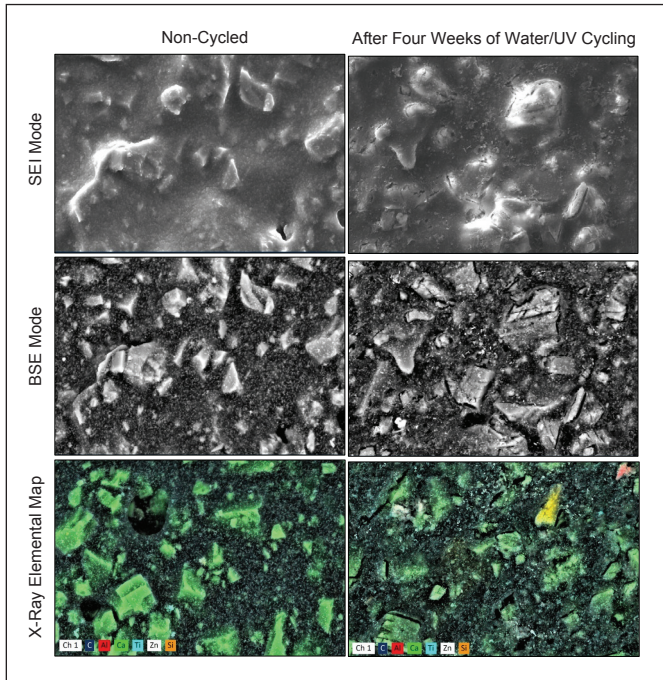
FIGURE 2—SEM images (1000X magnification) of Latex 2-based FRCs subjected to four weeks of cycling (right) and non-cycled. Cycled FRCs show crack formation, primarily at the polymer–CaCO₃ boundary, as well as fracture formation of the CaCO₃ particles.

Figures 2–5 show SEM and EDS images comparing FRCs after two weathering cycles (left images) and coatings simply stored at 25 °C with 50% RH. All FRCs contained TiO₂ and used a large (≈ 10 µm) particle size CaCO₃ as a filler. In addition to CaCO₃, Commercial Coating 2 also contained alumina (Al₂O₃). The alumina is most likely added as alumina trihydrate commonly used to impart flame retardancy.

The changes to the surface morphology of FRCs based on Latex 1 and Latex 2 after weathering show significant differences, *Figure 2* and *Figure 3*, respectively. The Latex 2-based coating shows (*Figure 2*, top left) crack formation near the CaCO_3 boundaries. These cracks are clearly more visible in the x-ray elemental images (*Figure 2*, bottom right) where fracturing of the CaCO_3 particles is also evident. In addition, small cracks formed in regions between CaCO_3 particles. The x-ray image (*Figure 2*, bottom left) shows removal of only a small amount of CaCO_3 from the surface.

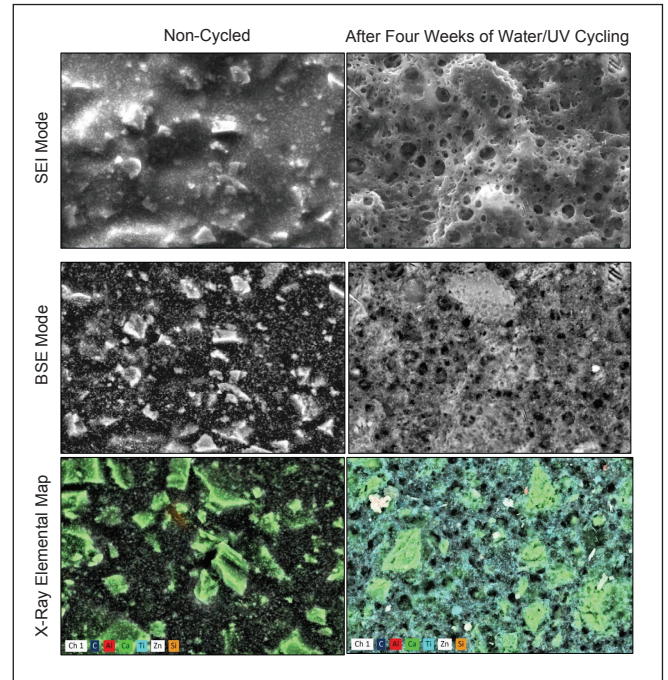
FIGURE 3—SEM images (1000X magnification) of Latex 1-based FRCs subjected to four weeks of cycling (right) and non-cycled. Cycled FRCs show a large degree of CaCO₃ (green) and organic (dark blue) loss, as well some fracturing of the CaCO₃.

Figure 3 shows significant changes to the surface of the FRC based on Latex 1 after weathering. The SEM images show significant removal of surface CaCO_3 along with dense void formation. In addition to carbonate removal, the x-ray image shows significant removal of organic phase (carbon signal).

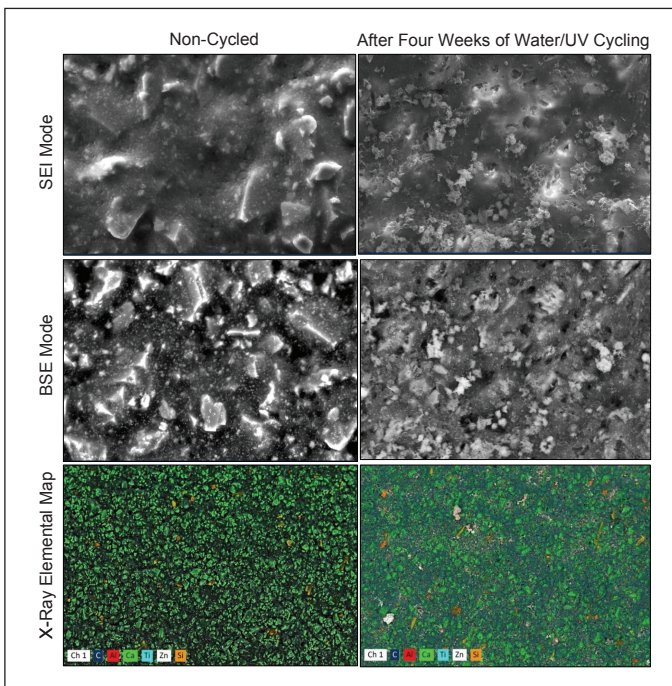
FIGURE 4—SEM images (1000X magnification, SEI and BSE modes) and x-ray elemental maps (100X magnification) of Commercial Coating 1-based FRCs subjected to four weeks of cycling (right) and non-cycled. X-ray elemental map images (bottom) show CaCO₃ (green) and organic (dark blue) loss. The source of the white Zn particles deposits was most likely from the galvanized substrate.

The formulation compositions of the commercial acrylic FRCs are not known. However, surface and cross-sectional SEM and surface elemental (EDS) images (see Figures 4–5) show both coatings contained TiO₂ and CaCO₃ and in one formulation, also contain Al₂O₃. Comparison of cross-sectional SEM images of the commercial acrylic and BASF FRCs suggests qualitatively similar filler and PVC.

The commercial FRCs appear to have degraded in a similar manner as the Latex 2-based coating although to a slightly greater extent with more loss of surface CaCO_3 . Commercial FRC 1 (*Figure 4*) had more surface void formation and slight surface cracking compared to Latex 2, but to a much lesser extent than Commercial FRC 2. Commercial FRC 2 (*Figure 5*) contained the two fillers CaCO_3 and Al_2O_3 , but only CaCO_3 fracturing and removal occurred after weathering. The Al_2O_3 particles showed no apparent fracturing and remained in the film with no void formation at the filler-polymer boundary.

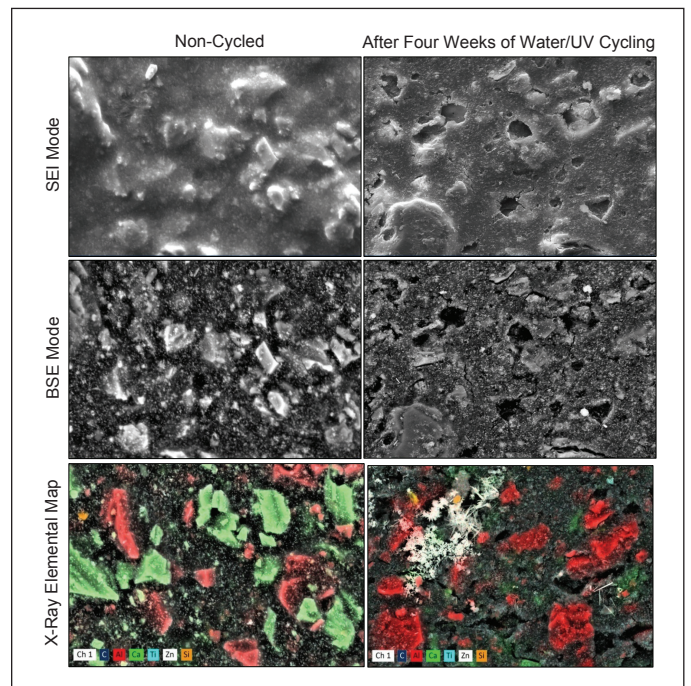
FIGURE 5—SEM images (1000X magnification, SEI and BSE modes) and x-ray elemental maps (100X magnification) of Commercial Coating 2-based FRCs subjected to four weeks of cycling (right) and non-cycled. The non-cycled FRC x-ray elemental map image (bottom left) shows the presence of Al₂O₃ (red) and CaCO₃ (green). Cycled FRC images (right) show a large degree of CaCO₃ was lost, while Al₂O₃ remained in the film. The source of the white Zn deposits was most likely from the galvanized substrate.

Commercial FRC 2 (*Figure 5*) was formulated with both CaCO_3 and Al_2O_3 where the weathered images clearly show that while CaCO_3 deteriorates and is lost from the coating, the Al_2O_3 particles remain intact and anchored within the film. This suggests Al_2O_3 is more inert to the surrounding environment than CaCO_3 . It may also be possible that Al_2O_3 particles are better anchored into the film through interaction with functional groups (e.g., acids) on the latex binder. This would be analogous to the integration of other metal oxides (e.g., TiO_2) with latex binders that promote adhesion and pigment-binder composite formation for improved coating opacity.

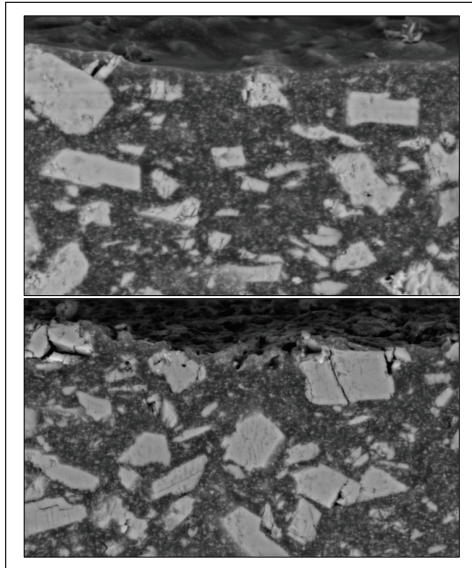
FIGURE 6—Cross-sectional SEM images of the FRC based on Latex 1 at 1000X magnification after four weeks of water/UV exposure (bottom) and no exposure (top). The images show degradation from the exposure process extended several microns from the exposed film surface, but the bulk of the film remained unaffected.

Film cross-section imaging, *Figure 6* and *Figure 7*, show that morphology changes in the coatings was confined close to the film surface to a depth of about $10\ \mu\text{m}$ to $20\ \mu\text{m}$ or about a CaCO_3 particle diameter. This is more clearly seen in *Figure 6* for Latex 1. The roughed appearance of the fractured CaCO_3 particles in the bulk of the film was most likely caused by the microtoming process.

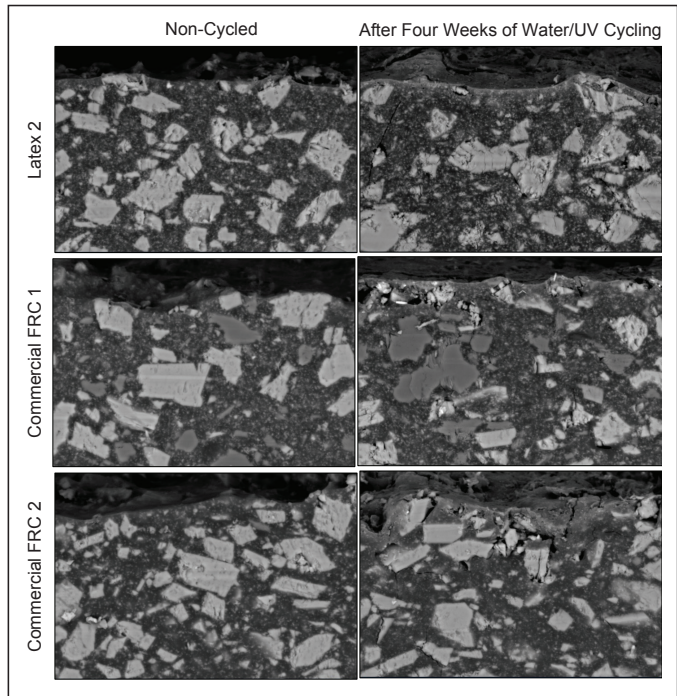
FIGURE 7—Cross-sectional SEM images (1000X magnification) of Latex 2 (top), Commercial FRC 1 (middle), and Commercial FRC 2 (bottom) after four weeks of cycling (right) and no exposure. The images show degradation from the exposure process extended several microns from the exposed film surface, but the bulk of the film remained unaffected.

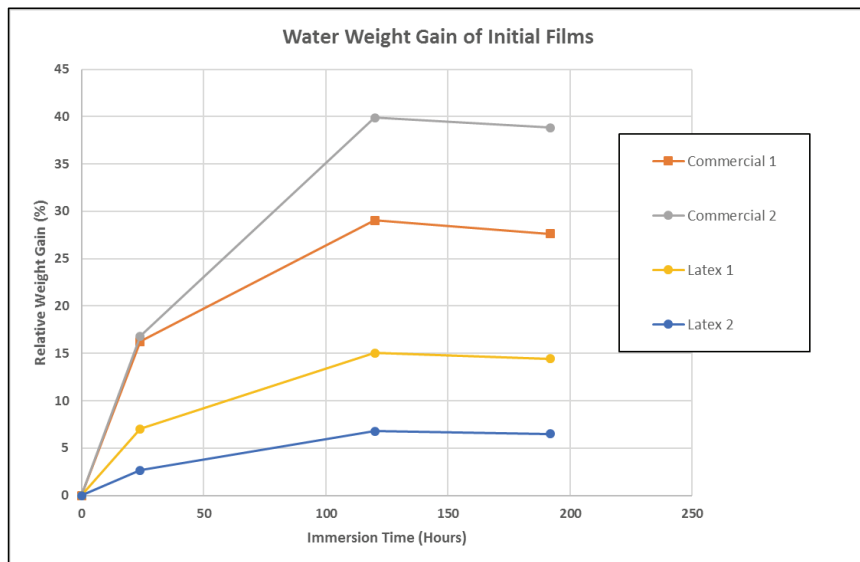
FIGURE 9—Water weight gain of free film FRCs as a function of immersion time. The error in the calculated percent weight gain was about 10% (e.g., 20% ± 2%).

Figure 9 shows water weight gain vs immersion time for free-film FRCs. The data show different degrees of water weight gain varying from about 6% to about 40% once equilibrium is reached at about 120 h immersion time. The measurement error was about 10% of the calculated percent weight gain. The coatings-based Latex 2 had a relative weight gain that was a little less than half that of Latex 1.

Water swelling of free films appears to play a role in coating defect formation. The relative amounts of water adsorption (Figure 9) appear to roughly correlate with visual film appearance (Figure 2) but not as well as with the extent of micro surface degradation. The commercial FRCs had the highest levels of water uptake and the most blister formation compared to the other coatings. This correlation is probably only a first approximation because of the cyclic nature of the test where water-soluble and dispersible formulation ingredients are extracted from the films, potentially affecting subsequent water uptake levels, mechanical properties, etc.
