# UNDERSTANDING EXTRACTIVE BLEED

## WOOD EXTRACTIVES: DISTRIBUTION, PROPERTIES, AND CLASSES

Joint Coatings/Forest Products Committee;  
Extractives Task Force

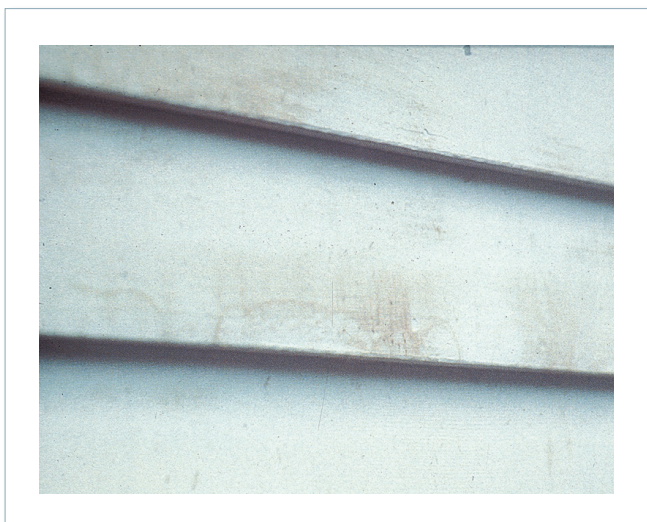
**Figure 1**—Diffused extractive bleed.

- Diffused discoloration of paint (*Figure 1*) typically results from penetration of the paint film by water or water vapor. This diffused discoloration usually occurs in the first few cycles of wetting or high humidity after paint application and can be attributed to a porous or thin paint coat that is insufficient to prevent water penetration. The water present as the carrier in waterborne finishes can also cause diffused discoloration. In these cases, discoloration is evident at the time of coating application, even before the coating has dried. Traditional stain-blocking primers were formulated with oil alkyds, which have proven to be best in preventing extractive bleed when applied as the first or primer coat. Recently, coating manufacturers have formulated waterborne stain-blocking primers to comply with regulations restricting solvents in paint. The waterborne systems do not work as well as traditional oil-alkyd-borne formulations, but manufacturers continue to improve them.

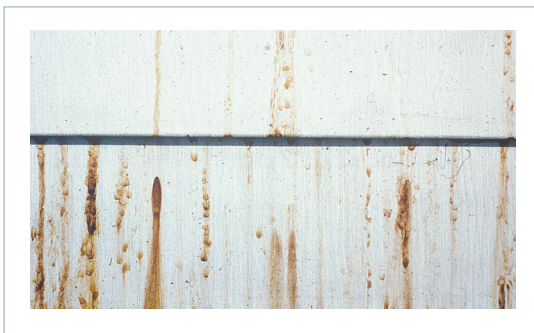
**Figure 2**—Run-down extractive bleed.

- Run-down or streaked type of extractive bleed (*Figure 2*) indicates that water has gained access to the back side of the siding. This can be caused by washing the wood with high-pressure washers, condensation of water vapor, leaks from improper flashing or building paper use, wind-blown rain behind the siding, or open joints in the wall that permit rainwater intrusion. In the case of siding that has not been end-primed after having been cut to fit around door and window openings, rain can cause this run-down form of extractive bleed. Rainwater easily soaks into the unsealed end grain of the siding where it dissolves extractives in the wood (*Figure 3*). These forms of stain are best prevented with good building practices.

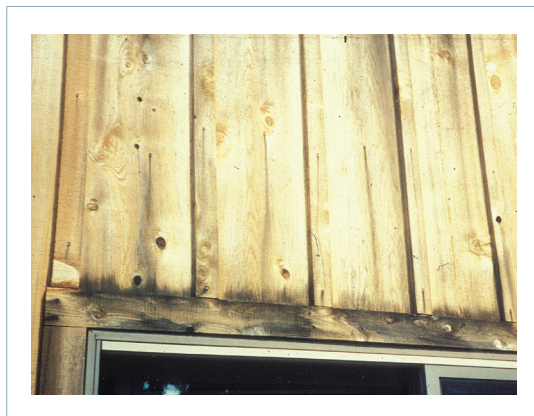
**Figure 3**—Extractive bleed from end-grain absorption of water. Note the fasteners have also caused iron staining.

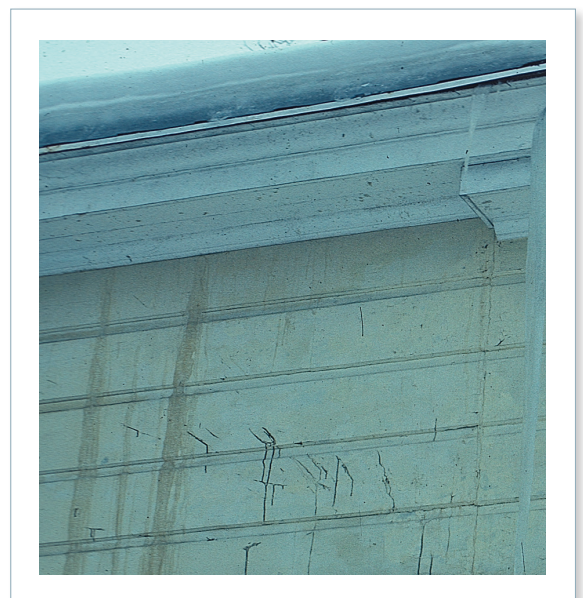
**Figure 4**—Ice dam on roof and gutter. The resulting water intrusion into the wall and behind the siding often causes run-down extractive bleed.

- Ice dams on roofs can cause water to overwhelm drains and gutters and flow behind rake boards, soffits, fascia, and siding, causing extractive bleed (*Figure 4*).

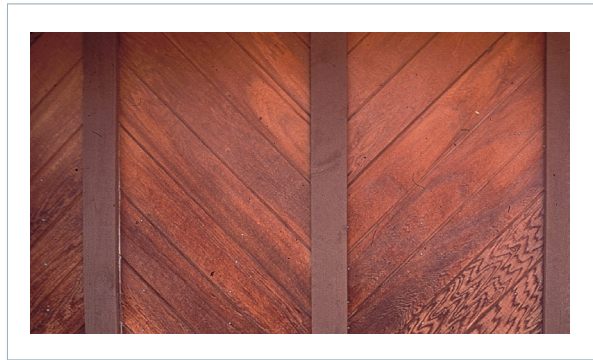
**Figure 5**—Uneven extractive bleed on siding.

- Unfinished wood that is allowed to weather naturally may take on various colors from extractives migrating to the surface (*Figure 5*).
- Initial MC of wood at the time of installation can contribute to extractive discoloration of coatings if the builder fails to acclimate the wood before it is installed. Unfortunately,

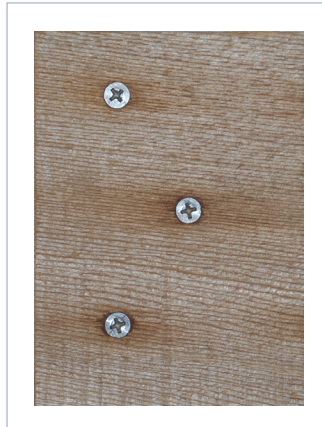
**Figure 6**—Extractive bleed around stainless steel fasteners.

- Nails and other fasteners damage wood, and water absorbed into these damaged areas may result in localized extractive bleed near the fasteners (*Figure 6*). This type of extractive bleed is minor and usually disappears within a few weeks. It should not be confused with blue-black iron stain, which is caused by the chemical reaction between iron leaching from low-quality fasteners and tannins in the wood (*Figure 7*). Tannins are one of many WSE and are found in high concentrations in several commonly used wood species (redwood, many cedars, oak). Minute amounts of iron cause this type of discoloration, and it is extremely difficult to remediate. Although the unsightly blue-black stain can be neutralized with aqueous oxalic acid solution, it will reappear if the source of iron—typically an inappropriate fastener—is not removed. If improper fasteners were

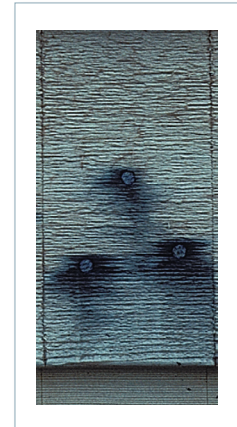
**Figure 7**—Iron stain around electro-plate galvanized fasteners.

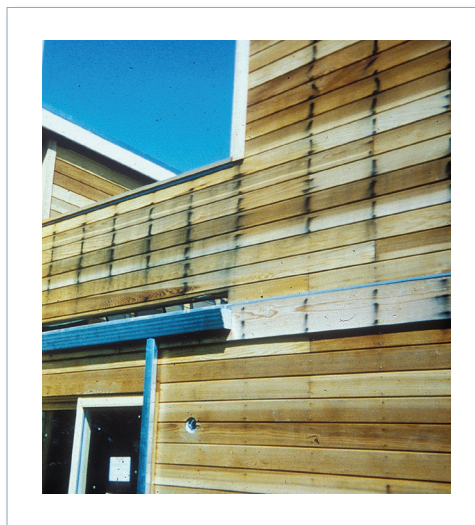
**Figure 8**—Iron stain on newly constructed home. The intent of the owner was to have a natural finish (lightly pigmented semitransparent stain) on the siding. To correct this, the siding will need to be replaced.

used to fasten siding to a structure, fixing this is almost impossible (*Figure 8*). The only long-term solution is to replace the siding—an expensive fix caused by careless selection of fasteners. Use of stainless steel fasteners or consulting with the wood supplier for recommendations regarding fastener choice will help avoid this problem.

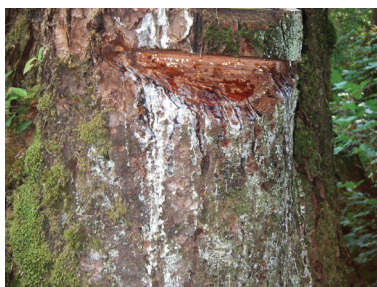
Figure 9—Pitch bleed from a cut on a tree.

of the wood and is particularly common over knots. Pitch and other resins are a defense mechanism that a tree uses to protect itself from harmful pathogens and insects following injury. When a tree's bark is damaged, pitch flows into these areas to protect the wound (Figure 9). Pitch also exists as a normal part of the wood of pines (*Pinus* spp.), spruces (*Picea* spp.), larches (*Larix* spp.), and Douglas-firs (*Pseudotsuga* spp.), and can be found in specialized wound structures called pitch pockets in the wood of most softwood species. Chemically speaking, pitch is a solution of natural rosins and turpentine. Although pitch is an SSE, it exudes from wood by bulk flow without solvent extraction.

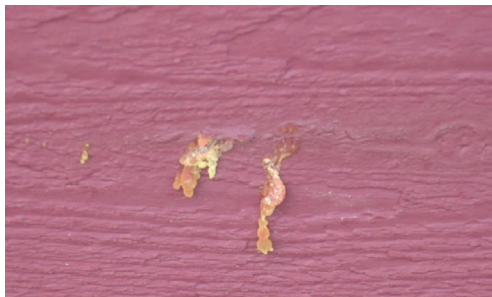
Figure 10—Localized pitch bleed.

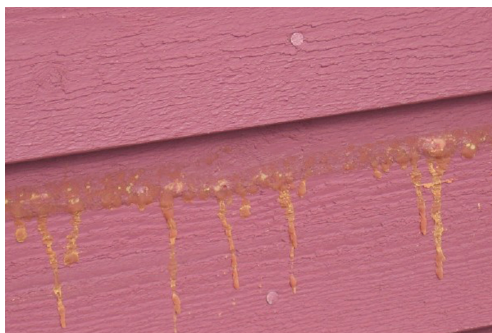
Figure 11—Large pitch pocket or seam.

If wood exhibits pitch bleed, there are several ways to remove the pitch depending on how fluid it is. If the pitch has not hardened (that is, if it still contains enough turpentine), it can be removed by dissolving it with turpentine or mineral spirits. Once it has hardened, it can be removed fairly easily with a putty knife, paint scraper, or sandpaper. If the pitch is still soft, such procedures smear it over the surface of the wood and paint. If the pitch cannot be easily dissolved with mineral spirits, it is probably best to let it harden and scrape it off. It may be possible to set small amounts of pitch by heating the wood with a heat gun, but this probably will not work for large pitch pockets, such as shown in *Figure 11*, or those located deep in the wood.
